INDOOR AIR QUALITY ASSESSMENT

**Aldrich V. Cousins Auditorium
Leominster High School
122 Granite Street
Leominster, Massachusetts**

Prepared by:
Massachusetts Department of Public Health
Center for Environmental Health
Emergency Response/Indoor Air Quality Program
May 2005

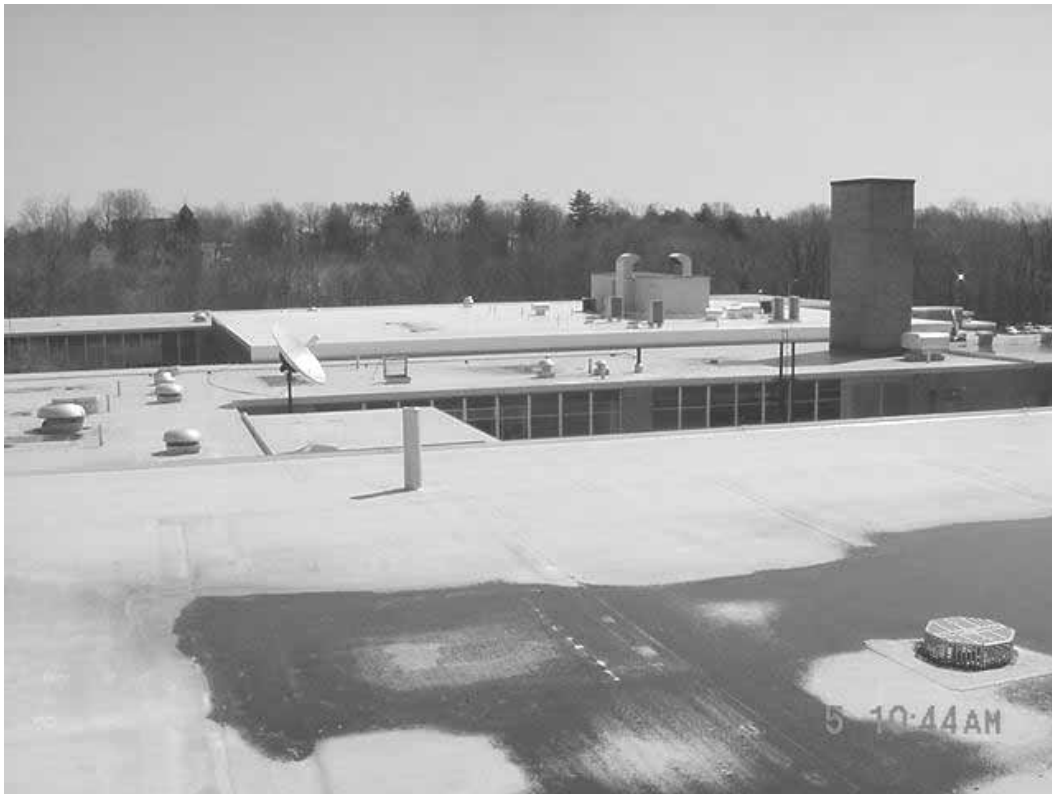
Picture 1

Rubber Membrane Roofs That Have Been Replaced

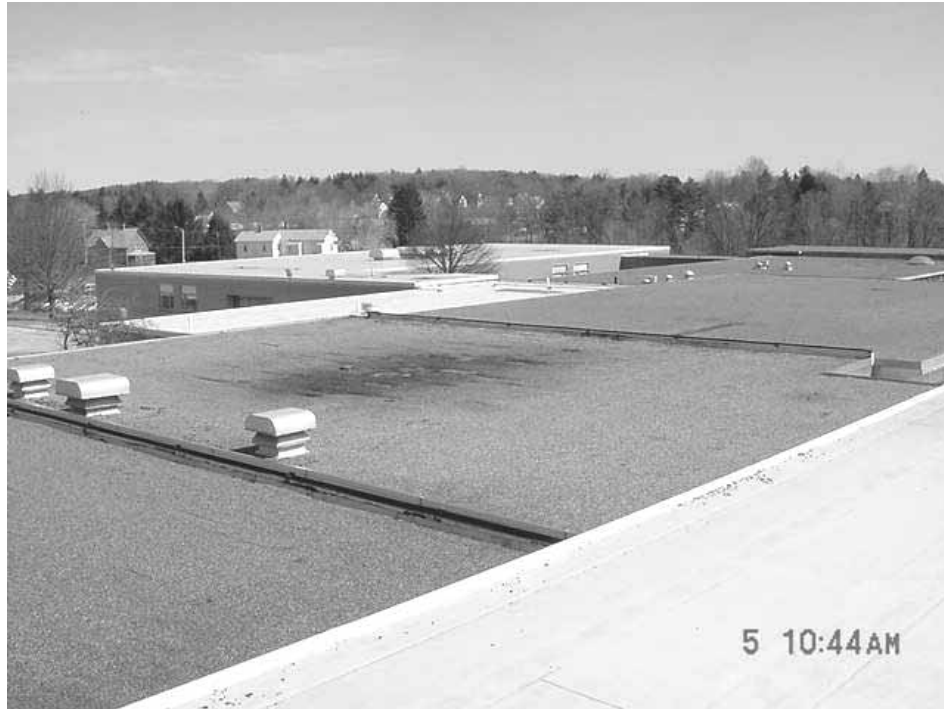
Picture 2

**Old Built-up Roofs (Asphalt/Gravel) in Foreground,
Rubber Membrane Roofs That Have Been Replaced in Background**

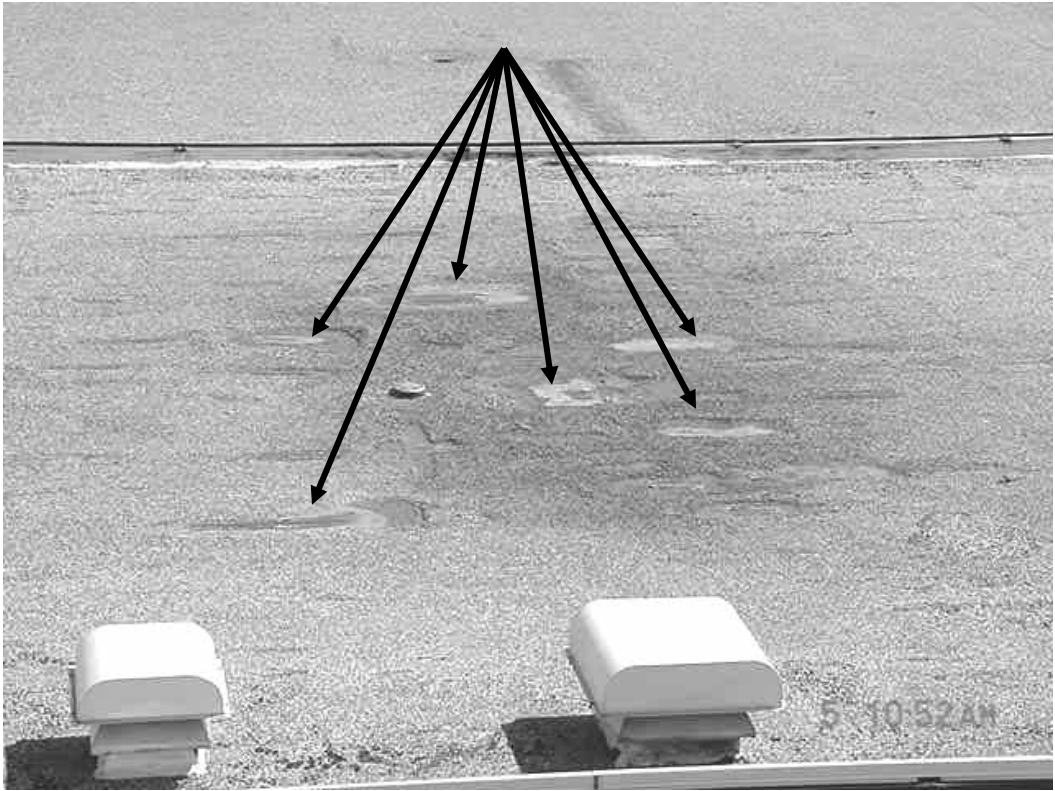
Picture 3

Previous Roof Patches

3. Until the roof can be replaced, continue working with roofing contractor in making roof repairs as needed to prevent further water penetration.
4. Continue with plans for school-wide roof replacement including the removal of historical “patches” intended for temporary repair. Once roof is repaired consideration should be made to repair/replace water damaged building materials.

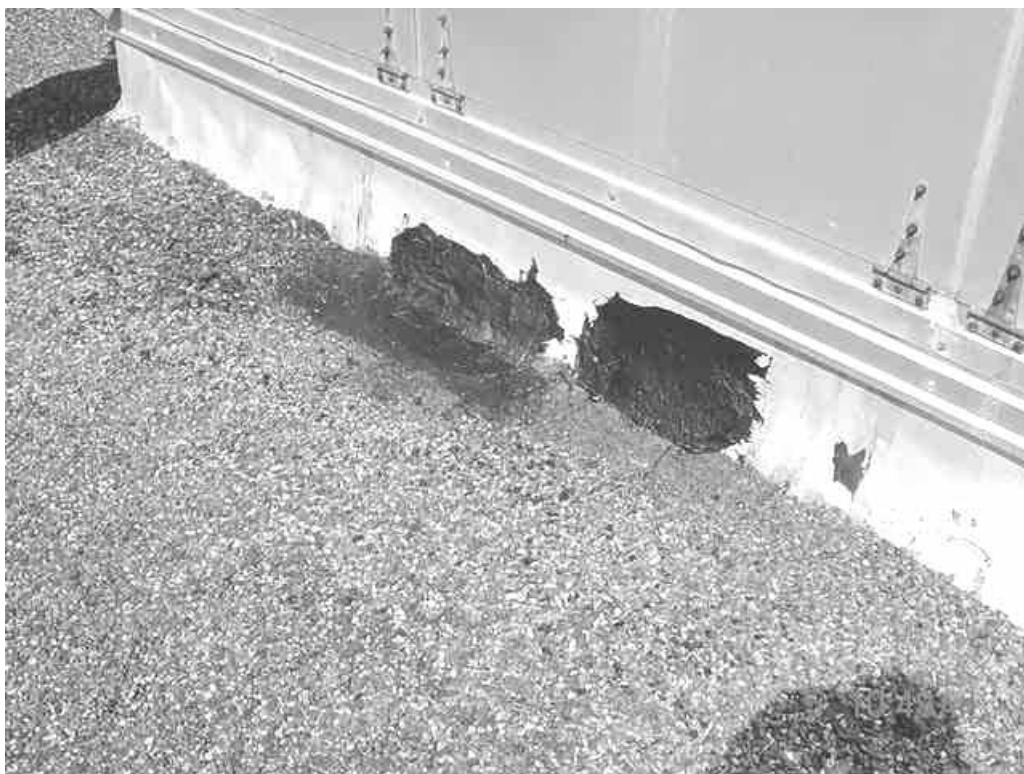
Picture 5

The LHS is a multi-level building with a number of different roofs that cover certain portions of the building (e.g., classroom wings, cafeteria, auditorium). The LHS including the auditorium has a history of chronic roof leaks. The LSD is reportedly in the process of a school-wide roof replacement program. Several portions of the roof at the LHS have been replaced over the last several years, with others in need of replacement (Pictures 1 and 2). Currently, three roof sections (including the auditorium) are under design for bid specification. According to Mr. Wood, the LSD anticipates the replacement of one or two roofs during the summer of 2005. In the interim, on-going attempts are reportedly made to temporarily repair certain areas to prevent water infiltration, as was evident from the number of patches observed (Picture 3). Mr. Wood reported that the LSD's roofing contractor had patched a number of areas above the auditorium the day preceding the MDPH visit, which is shown in Pictures 4 and 5.

“Fresh” Patches on Auditorium Roof

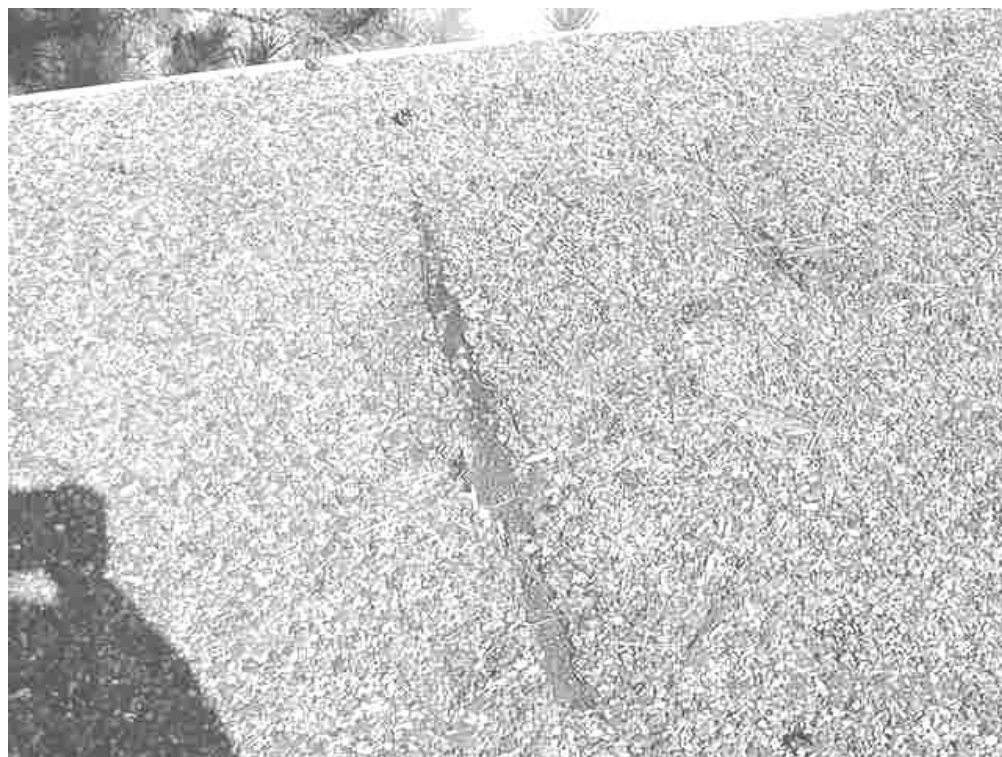
Picture 6

MDPH staff examined the roof and found the roof surface to be rippled and bulging in various areas (Picture 6). These problems can eventually result in damage to the roof membrane and create breaches in the building envelope enhancing water penetration into the building.

Bulging/Rippled Roof Surface

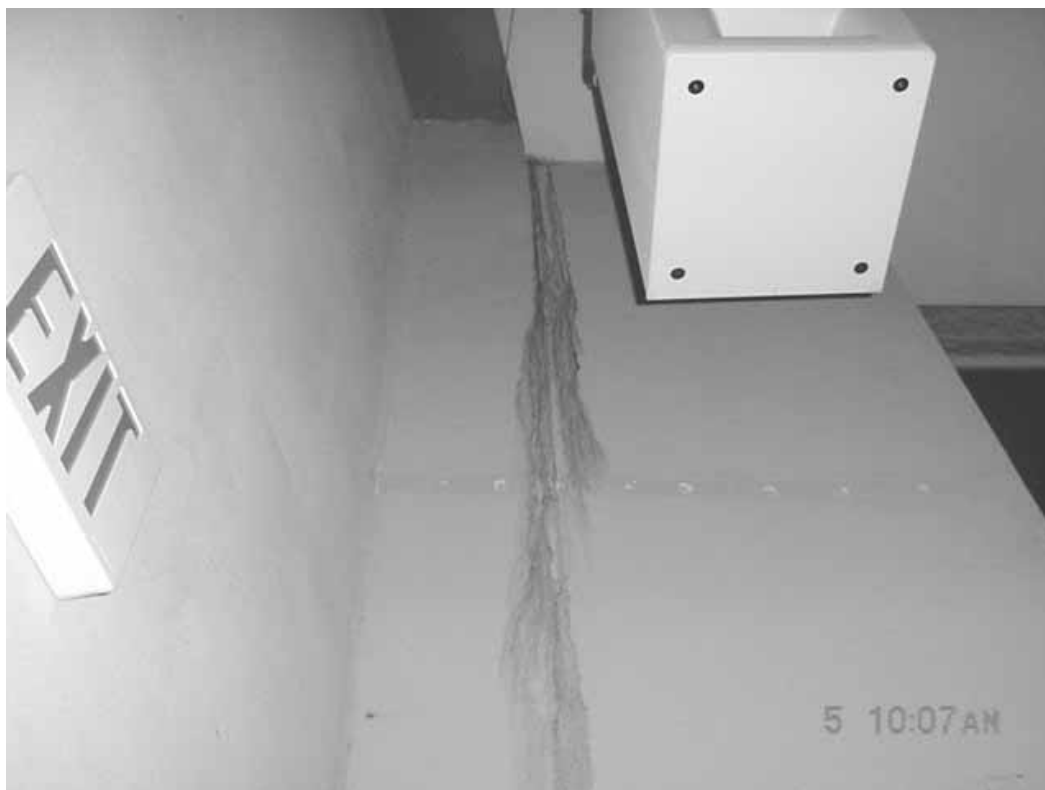
Picture 7

MDPH staff also examined conditions in the ceiling plenum directly below the auditorium roof. Although signs of chronic water infiltration (e.g., stained ceiling plaster, buckets stationed to catch water, rusting of metal beams and supports) were observed in several areas, no active mold growth was observed (Pictures 7 through 13). Staining in a

Water Damaged/Stained Wall Plaster

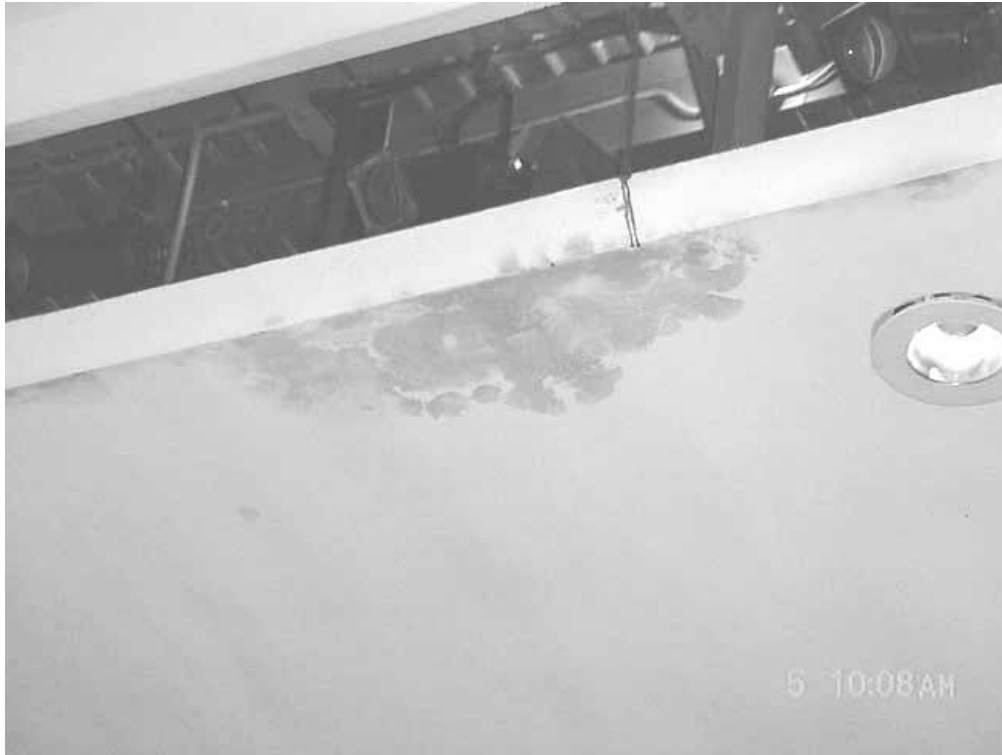
Picture 8

Water Damaged/Stained Ceiling Plaster

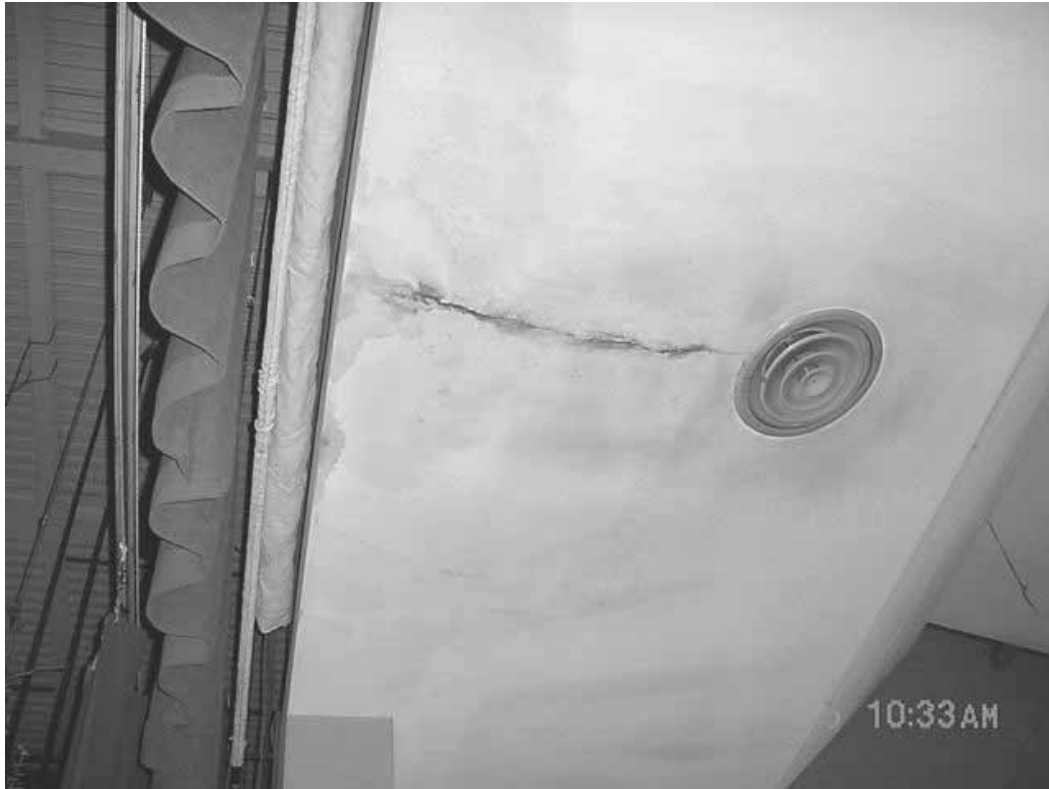
Picture 9

Water Damaged/Stained Ceiling Plaster

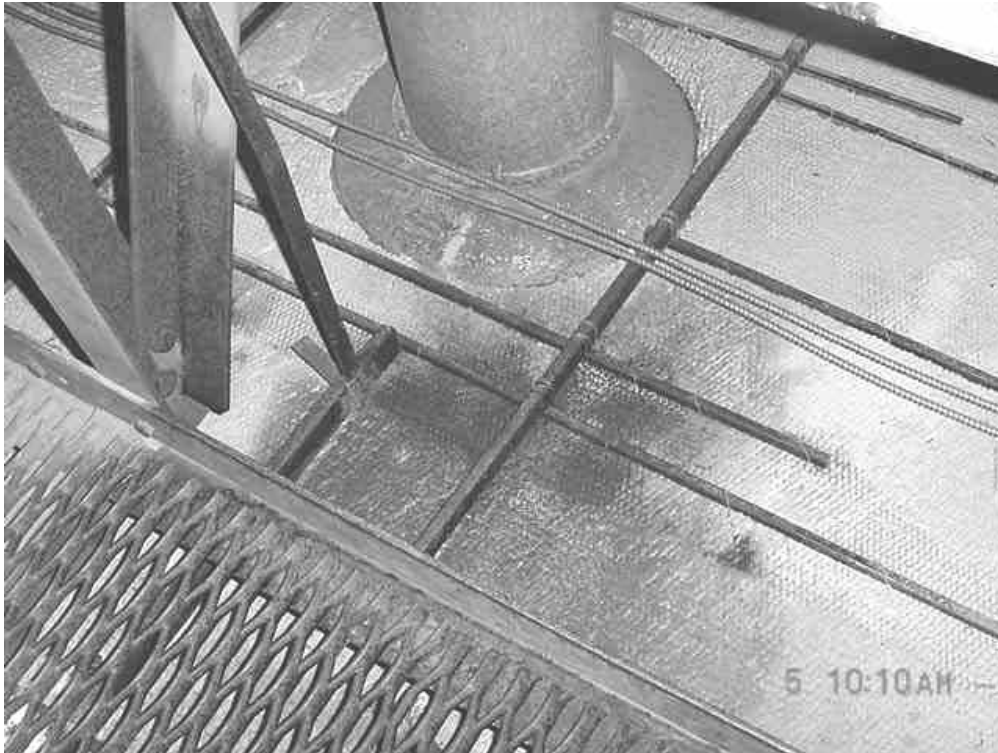
Picture 10

Water Damaged/Stained Ceiling Plaster in Plenum above Auditorium

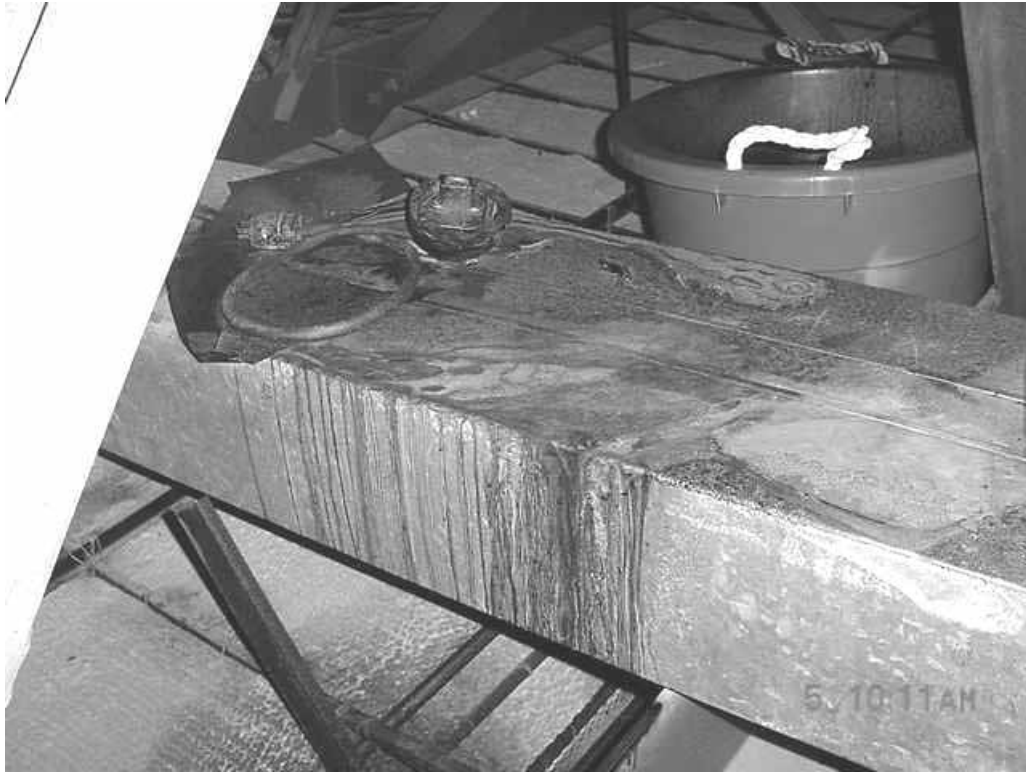
Picture 11

**Water Damaged/Stained Ceiling Plaster and Duct Work in Plenum above Auditorium,
Note Bucket Used to Catch Rain Water**

2. Empty buckets used to collect leaks regularly to prevent standing water, mold growth and associated odors. Clean and disinfect buckets and surface areas around leaks with an appropriate anti-microbial as needed.

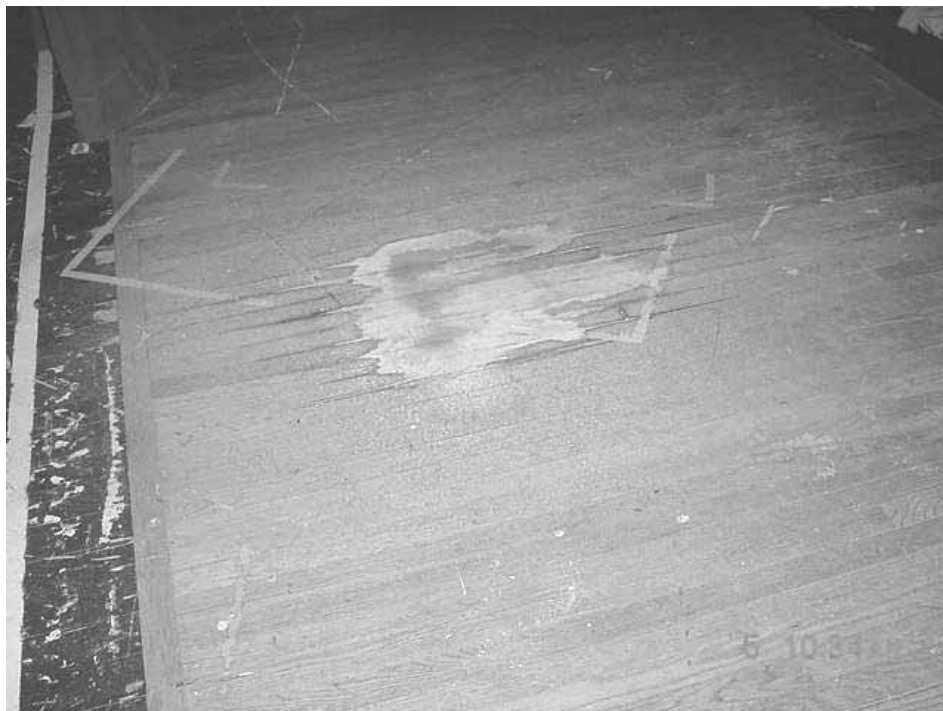
Picture 12

Water Damaged Wooden Stage Floor

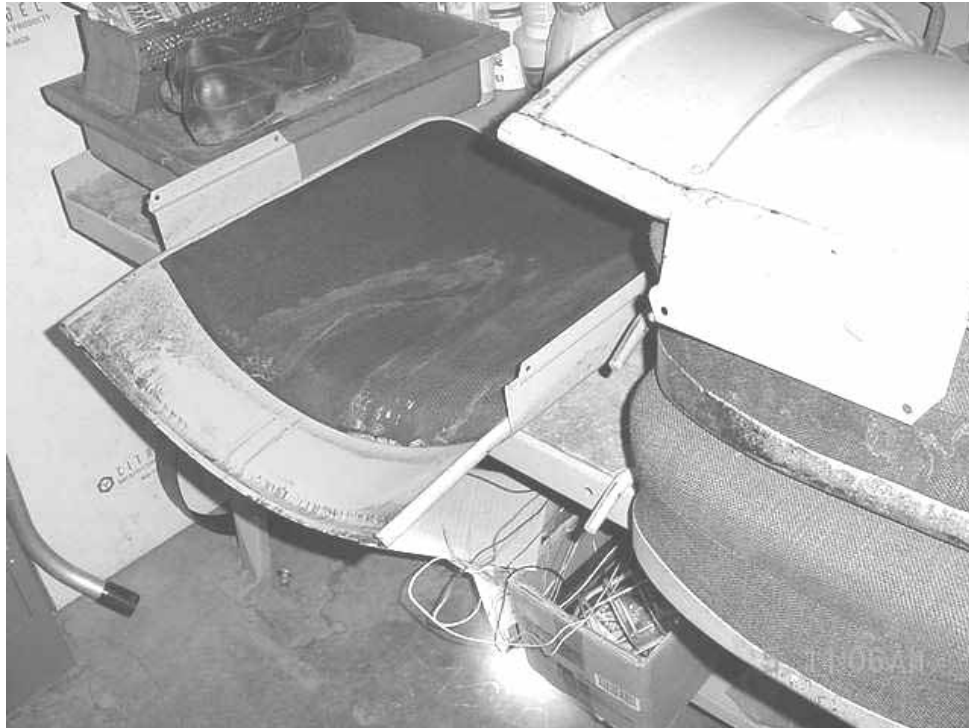
Picture 13

It was reported to MDPH staff that several water damaged chairs were found in the auditorium and were subsequently removed (Picture 13). MDPH staff examined every chair in the auditorium for water damage and or possible mold growth. One chair was found with water damage and removal was recommended (Picture 14). Repeated water damage to porous building materials (e.g., upholstered chairs, ceiling tiles, carpet) can result in microbial growth. The US Environmental Protection Agency (US EPA) and the American Conference of Governmental Industrial Hygienists (ACGIH) recommend that porous materials be dried with fans and heating within 24 to 48 hours of becoming wet (US EPA, 2001; ACGIH, 1989). If porous materials are not dried within this time frame, mold growth may occur.

**Water Damaged Upholstered Chairs That were Removed from Auditorium
(Picture Taken in Storeroom in Custodians' Office)**

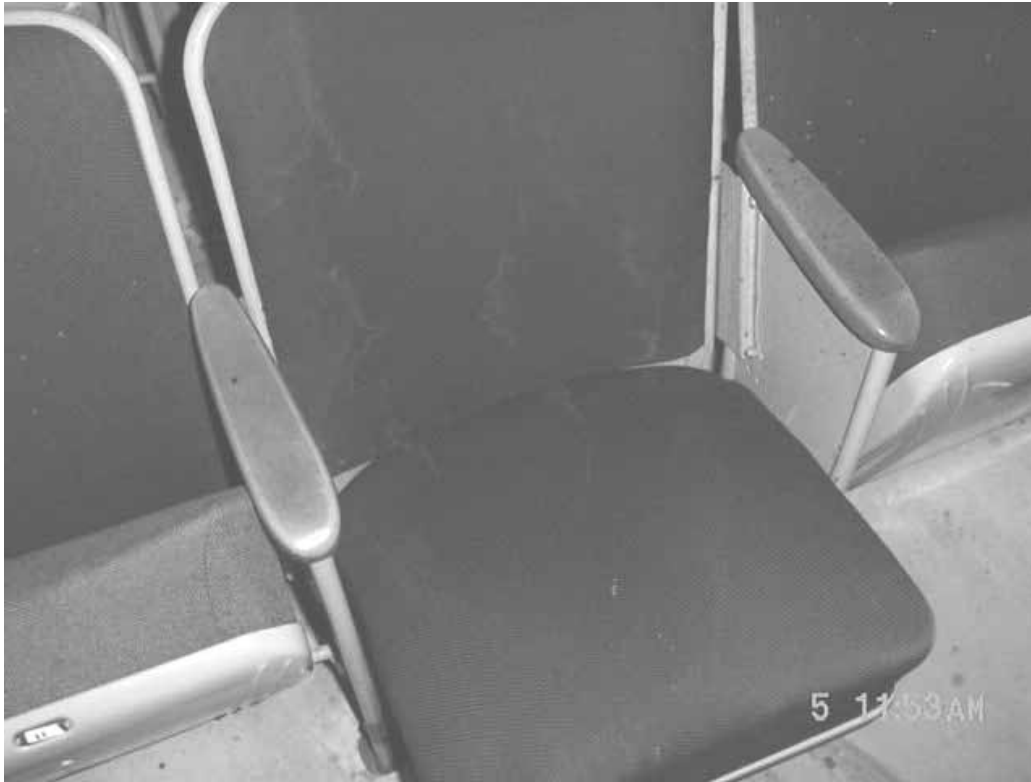
Picture 14

Water Damaged Chair (#110)

5. Remove/replace water damaged chair (#110) identified in Picture 14.
6. Continue to operate mechanical ventilation in the auditorium continuously during periods of school occupancy and change filters as per the manufactures’ instructions or more frequently as needed.
